# Absa AgriBusiness

## Agricultural Valuation Report of

Ptn 5 of the farm Middelfontein 663 LQ

(137.4787 Hectares in Total)

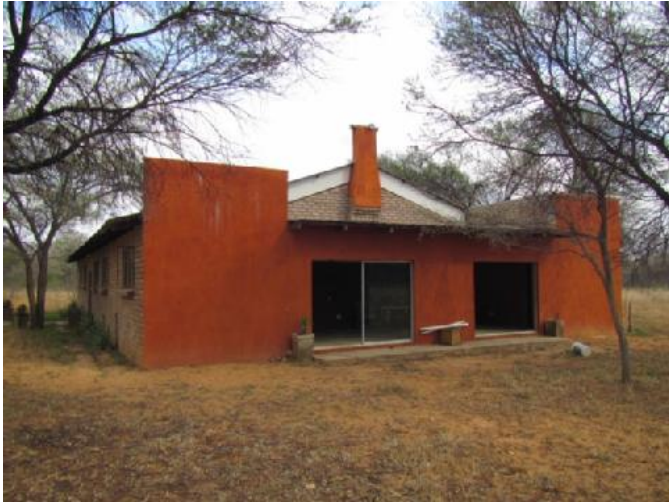
## Commercial (Shop/Hall)

A brick and mortar structure fitted with a pitch iron roof and cement floor. The building is in need of general maintenance.

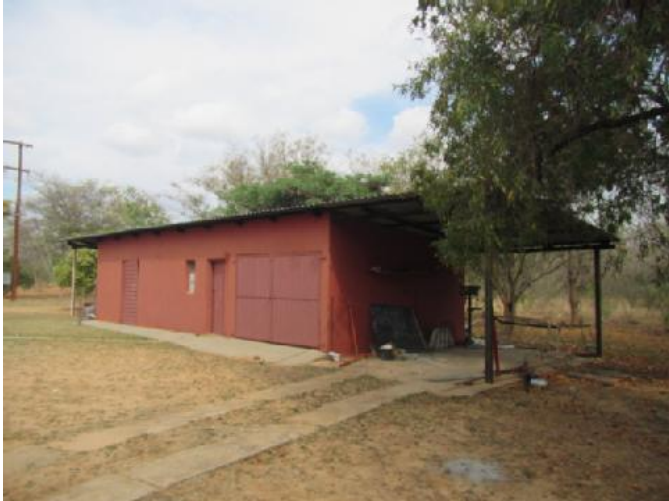
## Residential (Carport)

A steel structure fitted with an iron roof and grano floor. The carport is attached to the garage building.

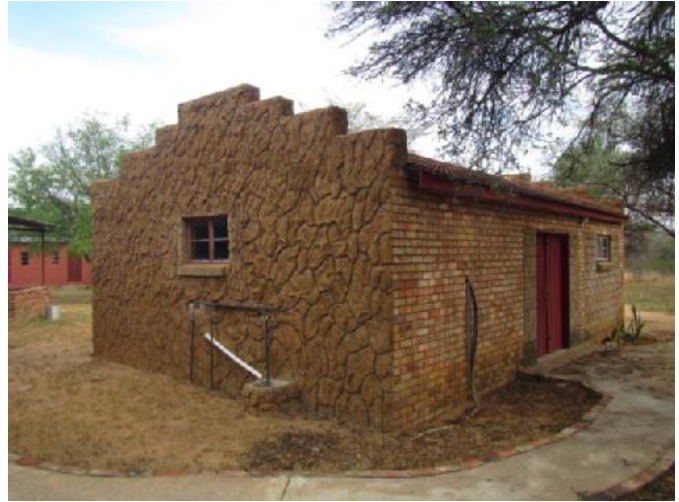
**Storage (Shed)**

A brick and mortar structure fitted with a pitch tile roof and cement floor. The building is in need of general maintenance.

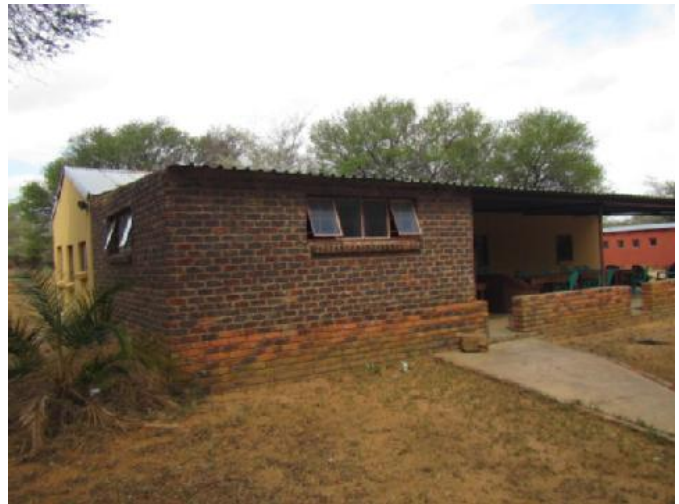
**Residential (Hall)**

A brick and mortar structure fitted with a pitch iron roof and cement floor. A covered patio is attached to the building. The building is in need of general maintenance.

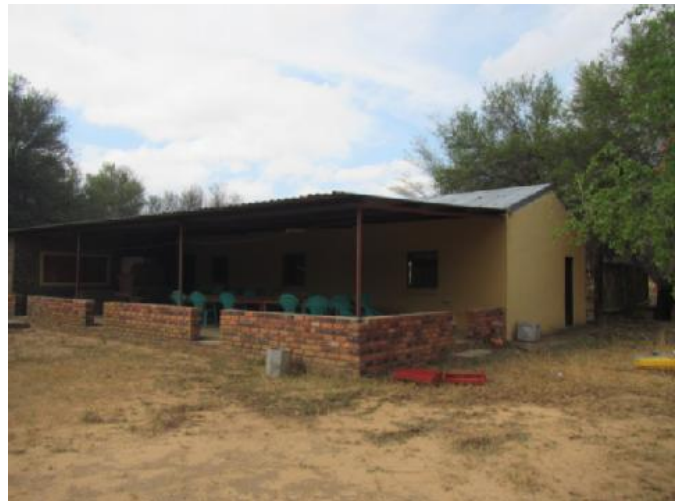
**Residential (Patio)**

An attached covered patio fitted with an iron roof and grano floor.

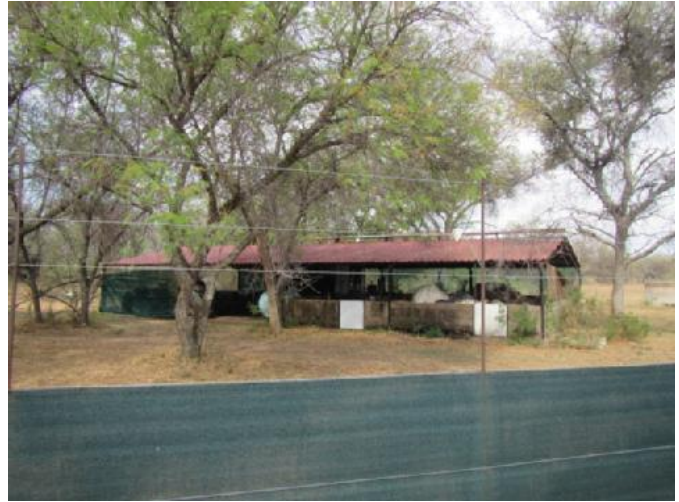
**Building (Lean-to)**

A steel structure fitted with a flat iron roof and grano floor.

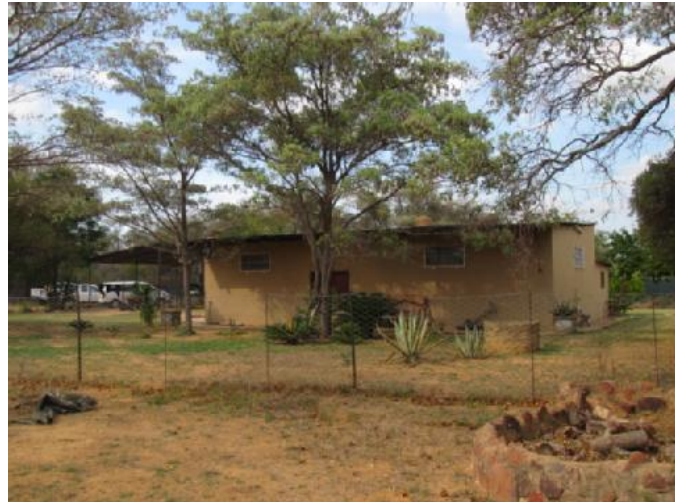
**Residential (Dwelling)**

A brick and mortar structure, plastered and painted walls fitted with an iron roof. Dwelling comprises three bedrooms, one lounge, one dining room, one family room, one bathroom, kitchen and scullery.

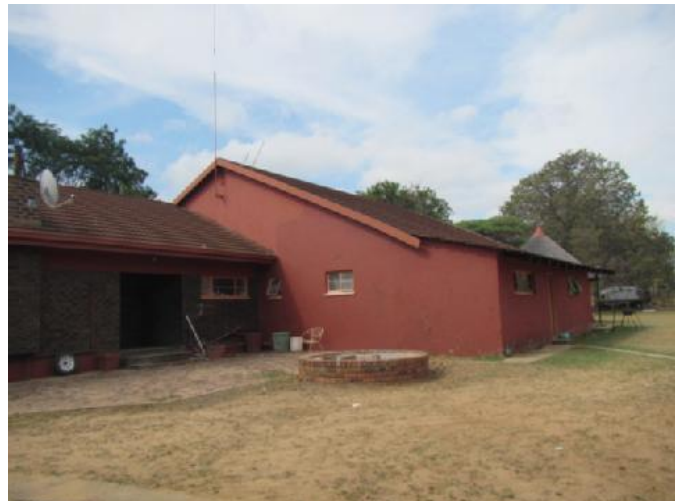
**Residential (Dwelling) 2**

A brick and mortar structure, partially plastered and painted walls fitted with a pitch tile roof and tile floors. Dwelling comprises four bedrooms, one lounge, one dining room, one family room, two bathrooms with a guest toilet, kitchen and scullery with a pantry.

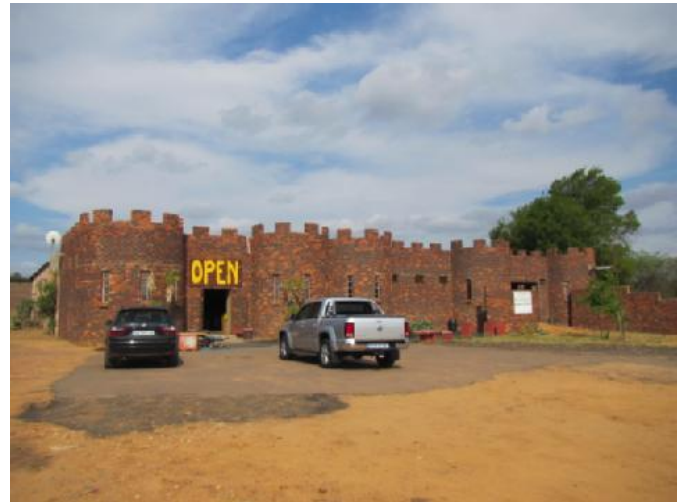
**Building (Road Stall)**

A brick and mortar structure fitted with an iron roof. There is a large farm shop (manufacturing and selling of "biltong" products and game meat) with related facilities (cold storage and meat preparation room).

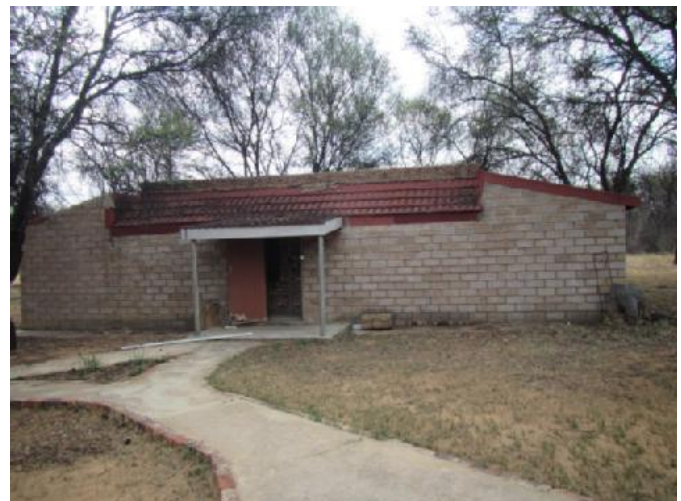
**Residential (Chalets)**

A brick and mortar structure fitted with a mono pitch iron roof and cement floor. The building is in need of general maintenance.

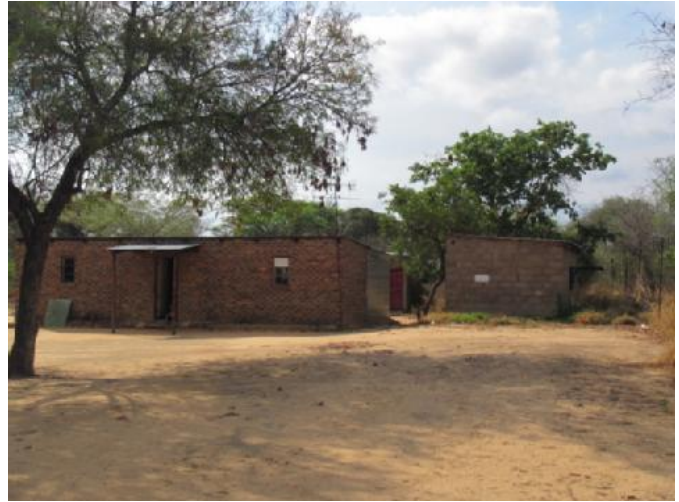
**Staff (Staff Buildings)**

Brick and mortar structures fitted with iron roofs and grano floors.

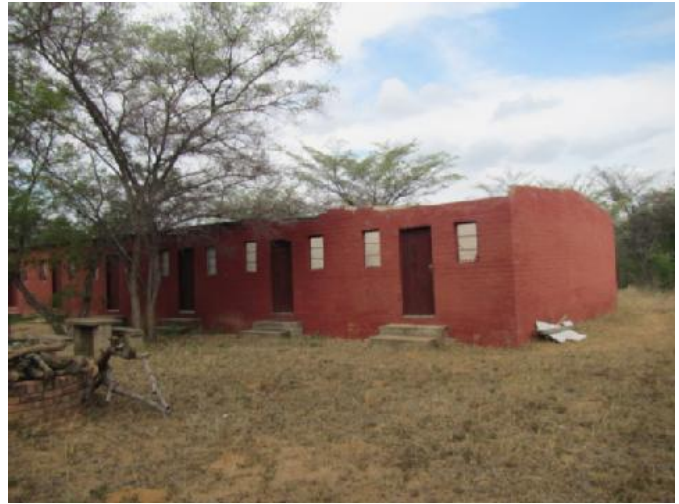
**Residential (Rooms)**

The roof of the building is removed. The rooms are therefore not valued.

Since the previous valuation the fixed improvements have deteriorated and are in need of urgent maintenance. Most of the structures were vacant on day of inspection. The accommodation rooms' roof is removed, and therefore not valued in this report.
